**Flood Control Project Maintenance
Levee Inspections**

Fall 2015 Levee Maintenance Deficiency Summary Report

Sacramento River Basin

Reclamation District No. 0501 Ryer Island

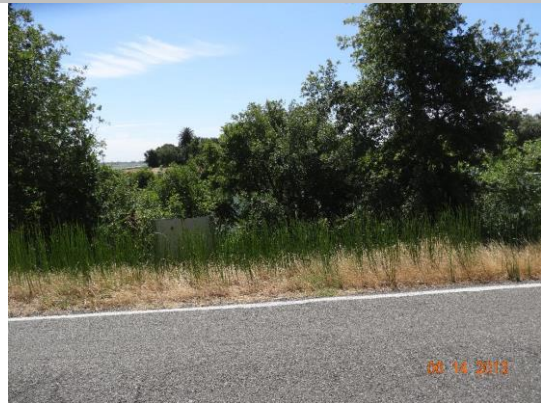
Photo 1 of 3 : UCIP_FA_2015_3555.jpg

LM Start	0.04	Rating **	M	Issue No.	66 (cont)
LM End	0.04	Issue Type +	En	Location *	WS

Waterward shoulder--sign on waterward slope.

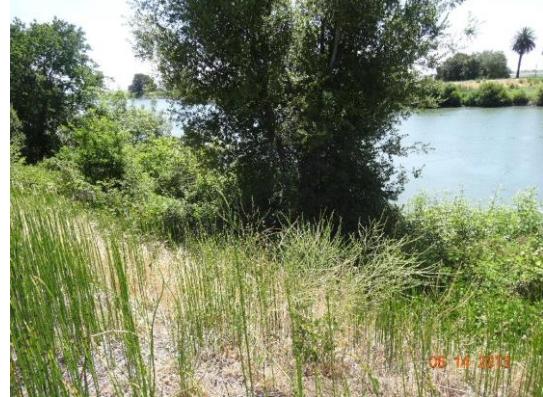
Photo 3 of 3 : UCIP_FA_2015_3676.jpg

LM Start	0.04	Rating **	M	Issue No.	66 (cont)
LM End	0.04	Issue Type +	En	Location *	WS
Category	Supplemental			GPS Latitude/Longitude	
				Start	End
Item	DWR UCIP Field Study			38.254035 °	38.254035 °
				-121.601757 °	-121.601757 °
DWR ID					
Action/Comments					
Inspector Comments: FS_ID:44878					
DS_ID:21096					
EP_NO: 3635					
FS_HLM: 0.03					
Repair Type: Non-Urgent					
Crossing Status: Found

View of waterward side--no signs of crossing.

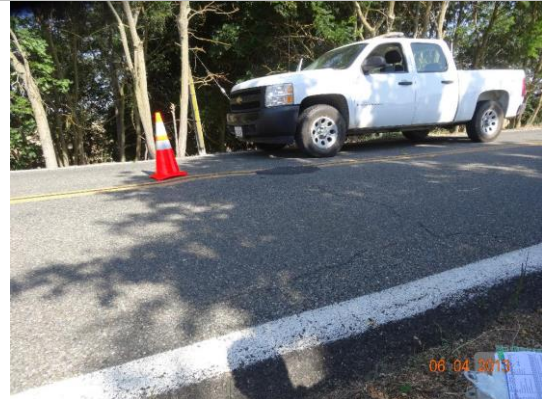
Photo 2 of 3 : UCIP_FA_2015_3656.jpg

UCIP Comments: Damage present on levee crown--unable to confirm if damage due to leak in pipe. Signs of repair work on crown, however, no permit found to document recent damage to levee or repair work. New PVC pipe has been sleeved through the existing 6-inch pipe. Unable to determine if crossing is still in use, if not, crossings needs to be removed according to CVFPB Title 23 requirements.

View of crown at crossing.

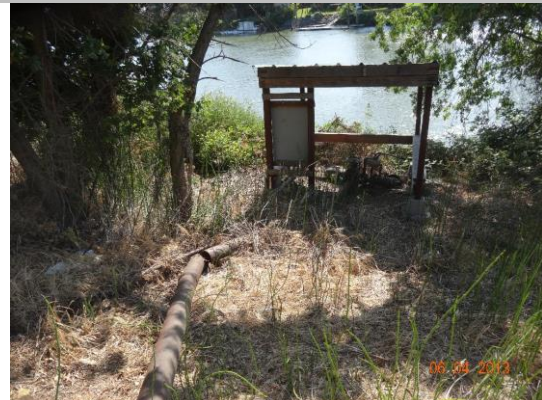
Photo 3 of 3 : UCIP_FA_2015_3657.jpg

Overview of waterward side--pump, abandoned pipe section, and conduit.

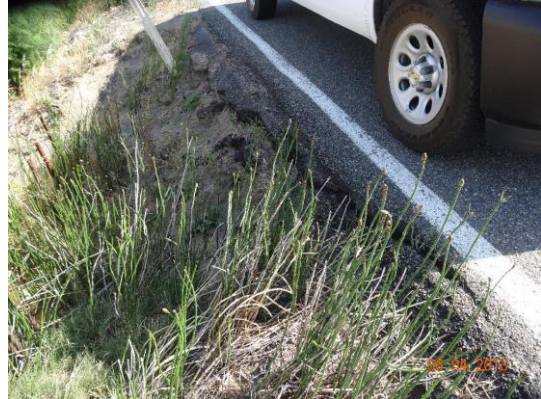
Photo 1 of 3 : UCIP_FA_2015_3658.jpg

LM Start	0.39	Rating **	M	Issue No.	980
LM End	0.39	Issue Type +	En	Location *	WS
Category	Supplemental			GPS Latitude/Longitude	
				Start	End
Item	DWR UCIP Field Study			38.249197 °	38.249197 °
				-121.603061 °	-121.603061 °
DWR ID					
Action/Comments					
Inspector Comments: FS_ID:32524 DS_ID:21031 EP_NO: N/A FS_HLM: 0.38 Repair Type: Non-Urgent Crossing Status: Found

Crown hinge point damaged, roadway section missing.

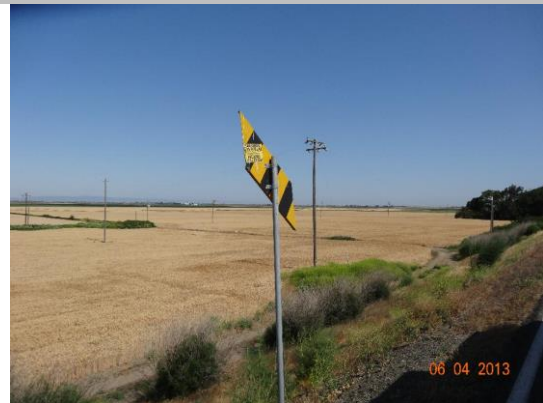
Photo 1 of 3 : UCIP_FA_2015_3693.jpg

LM Start	0.44	Rating **	M	Issue No.	981
LM End	0.44	Issue Type +	En	Location *	WS
Category	Supplemental			GPS Latitude/Longitude	
				Start	End
Item	DWR UCIP Field Study			38.248519 °	38.248519
				-121.602972 °	-121.602972
DWR ID					
Action/Comments					
Inspector Comments: FS_ID:41409 DS_ID:21032 EP_NO: N/A FS_HLM: 0.43 Repair Type: Non-Urgent Crossing Status: Found UCIP Comments: Need to contact owner and ask for emergency contact information and permit number. 8/21/13 Contacted Gas Control Division under the emergency contact No. 1-877-723-3344. Message has been forward to Brian Habersack at 916-859-4700, email: bhabersack@gasbiz.com. FIELD_STRUCT_DESC: 6-inch Steel Gas line through the levee 60-feet below the crown. Markers on both shoulders (Permit No. 17033, 2014). FS Date: 06/04/2013

Overview of landside at crossing. Marker on shoulder.

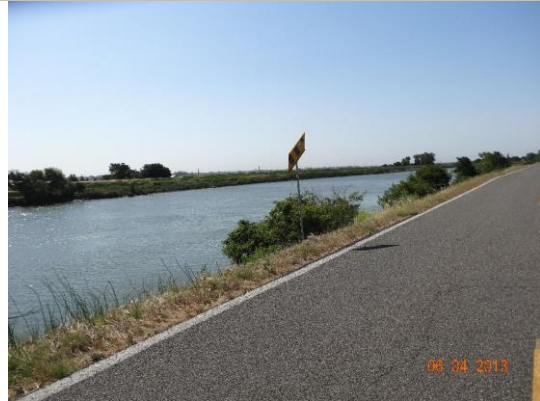
Photo 2 of 3 : UCIP_FA_2015_3694.jpg

Overview of waterside at crossing. Marker on shoulder.

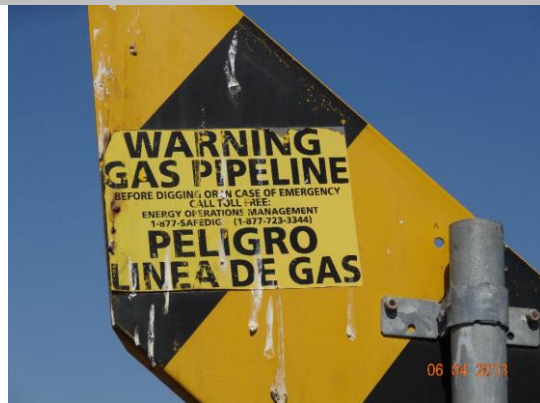
Photo 3 of 3 : UCIP_FA_2015_3695.jpg

Inspector Comments: FS_ID:41409
 DS_ID:21032
 EP_NO: N/A
 FS_HLM: 0.43
 Repair Type: Non-Urgent
 Crossing Status: Found
 UCIP Comments: Need to contact owner and ask for emergency contact information and permit number. 8/21/13 Contacted Gas Control Division under the emergency contact No. 1-877-723-3344. Message has been forward to Brian Habersack at 916-859-4700, email: bhabersack@gasbiz.com.
 FIELD_STRUCT_DESC: 6-inch Steel Gas line through the levee 60-feet below the crown. Markers on both shoulders (Permit No. 17033, 2014).
 FS Date: 06/04/2013

Gas line contact information on the sign.

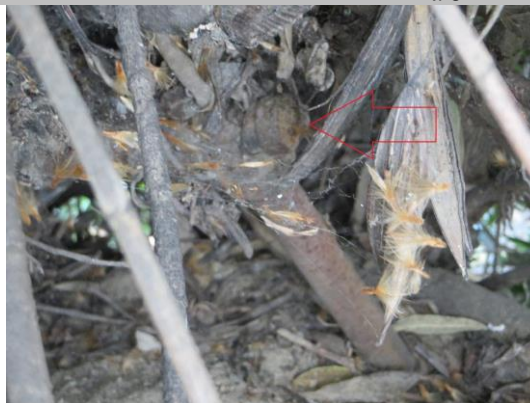
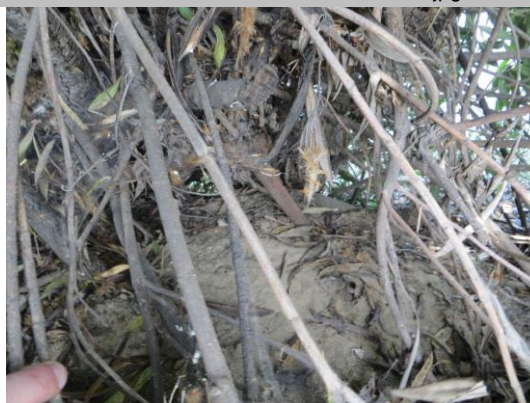
Action/Comments					
Inspector Comments: FS_ID:44643 DS_ID:21089 EP_NO: 2683 FS_HLM: 0.69 Repair Type: Non-Urgent Crossing Status: Indicator Found UCIP Comments: Appears abandoned and if so should be done so properly. FIELD_STRUCT_DESC: 2-inch steel water pipe and 1-inch steel electrical conduit through the levee, both 3.0 feet below the crown. Portion of pipe visible under oleanders on LS shoulder may be part of this crossing. No evidence remains on WS slope. FS Date: 04/21/2015

Pipes visilbe under oleander on LS shoulder.

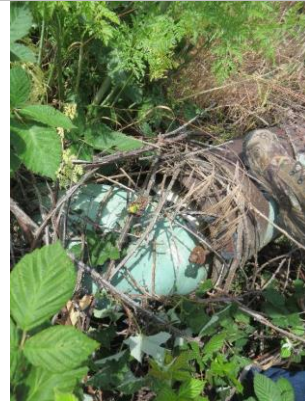
Photo 3 of 3 : UCIP_FA_2015_6845.jpg

LM Start	0.97	Rating **	U	Issue No.	983 (cont)	
LM End	0.97	Issue Type +	En	Location *	LS	
Category	Supplemental			GPS Latitude/Longitude		
				Start	End	
Item	DWR UCIP Field Study			38.240808 °	38.240808 °	
				-121.603628 °	-121.603628 °	
DWR ID						
Action/Comments						
Inspector Comments: FS_ID:44655 DS_ID:21034 EP_NO: N/A FS_HLM: 0.97 Repair Type: Urgent Crossing Status: Found UCIP Comments: Unauthorized PVC pipe. Annular space not grouted. 14-inch pipe open on both ends. FIELD_STRUCT_DESC: 14-inch steel irrigation pipe through the levee, 3.2 feet below the crown. (USACE-1959). 10-inch PVC pipe sleeved through 14-inch with a siphon breaker on the LS shoulder. This entry matches the Drainage or Irrigation Structure referenced in O&M manual (HLM 1.0). FS Date: 04/21/2015

10-inch PVC pipe sleeved through 14-inch steel pipe on WS slope. No grout identified.

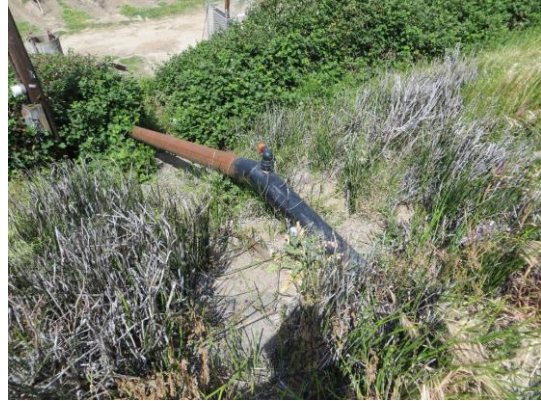
Photo 2 of 3 : UCIP_FA_2015_6151.jpg

Inspector Comments: FS_ID:44659
 DS_ID:21086
 EP_NO: 13233
 FS_HLM: 1.84
 Repair Type: Non-Urgent
 Crossing Status: Found
 UCIP Comments: Annular space between pipes not grouted. Steel plate partially covers openings between pipes.
 FIELD_STRUCT_DESC: 14-inch steel pipe through the levee, 2.5-feet below the crown. Cutoff wall around pipe at center of levee. Pump and check valve in pump house on waterward slope. Service pole on landward slope. (Permit No. 13233-1982) 8-inch steel irrigation pipe sleeved through 14-inch (under Permit No. 11813-1, 2013). A 1.5 and a 2.5-inch electrical conduit at same location. Siphon breaker on both shoulders.
 FS Date: 04/21/2015

8-inch steel pipe with vent/siphon breaker on LS shoulder. Pipe sleeved through 14-inch steel pipe. Electrical conduit visible next to pipe.

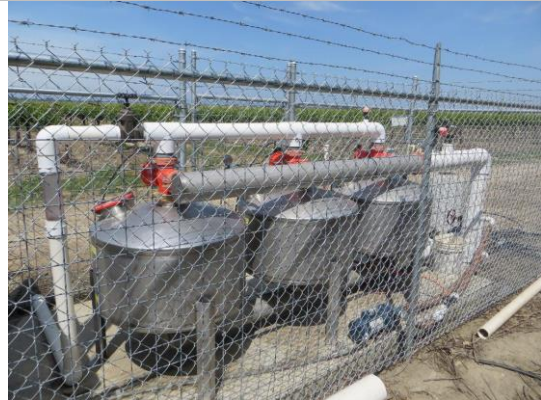
Photo 3 of 3 : UCIP_FA_2015_6152.jpg

Sand filter plant on LS toe.

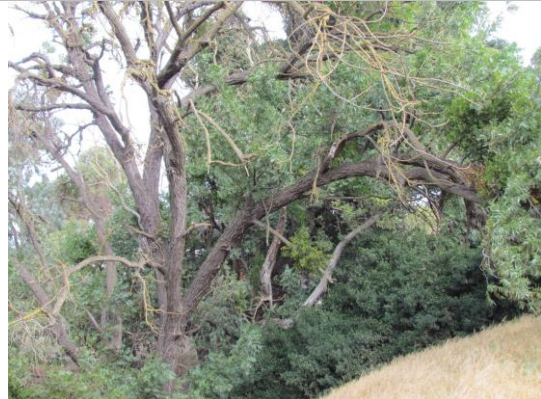
Photo 1 of 1 : FA_2015_RD0501_169_6_20151005_00015.jpg

LM Start	2.32	Rating **	U	Issue No.	6
LM End	2.32	Issue Type +	Ma	Location *	LS
Category	Earthen Levee			GPS Latitude/Longitude	
				Start	End
Item	Trim / Thin Trees			38.221455 °	38.221455 °
				-121.603508 °	-121.603508 °
DWR ID	DWR_RD0501_01_f_2015_6				
Action/Comments					
Trim trees to at least five feet above ground level. Inspector Comments: This tree at this location is dead and poses a threat that could cause injury to persons or levee damage.

This photo shows an old dead cotton wood tree at the landside levee toe.

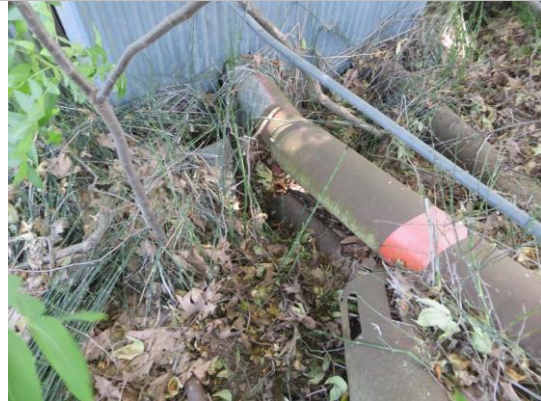
Photo 1 of 3 : UCIP_FA_2015_6153.jpg

Inspector Comments: FS_ID:44683
 DS_ID:21021
 EP_NO: N/A
 FS_HLM: 2.343
 Repair Type: Non-Urgent
 Crossing Status: Found
 UCIP Comments: Appears abandoned and if so should be done so properly. Discarded pipe on WS slope should be removed.
 FIELD_STRUCT_DESC: 10-inch steel irrigation pipe through the levee, 2.5-feet below the crown. Pump and gate valve in pump house on waterward slope. a 4'X4' concrete distribution box, power pole, and meter on LS toe (USACE-1959). This entry matches the Drainage or Irrigation Structure referenced in O&M manual (HLM 2.50).
 FS Date: 04/21/2015

Pipe, conduit, and pipe debris on WS slope.

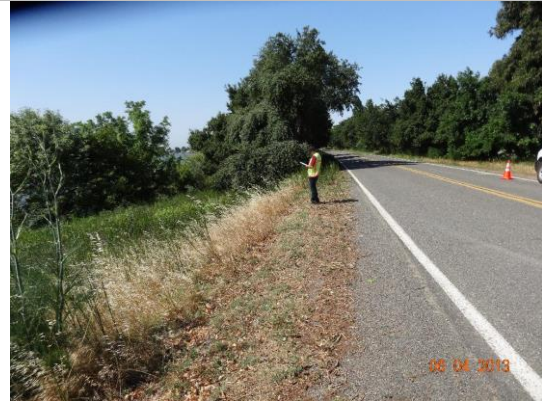
Photo 1 of 3 : UCIP_FA_2015_3696.jpg

Action/Comments					
Inspector Comments: FS_ID:32526 DS_ID:21022 EP_NO: 2742 FS_HLM: 2.83 Repair Type: Non-Urgent Crossing Status: Found UCIP Comments: Dense vegetation limits the inspector's visibility to identify signs of pipe failure (leaks) through the levee slopes. Recommend removing vegetation along pipe alignment to conduct proper inspection of structure and appurtenances. Additional notes: pump was running during inspection, 16-inch pipe debris section located on landward side, view of standpipe and support structure on waterward side does not match structure description--need to determine if crossing has been altered. FIELD_STRUCT_DESC: 16-inch drainpipe through the levee, 3.6 feet below the crown. Cutoff walls around pipe at center of levee. Siphon breaker on apex of pipe at landward shoulder. Pump house on landward shoulder. Pipe discharges into 48-inch pipe with screw gate on landward side. (Permit No. 2742-1959). Repairs made to pipe and a portion replaced, from landward shoulder to discharge end on waterward side, under Permit No. 15380 (1999). Rock revetment placed on waterward slope. Revegetation in progress on waterside. FS Date: 06/04/2013

Overview of crown at crossing, looking downstream.

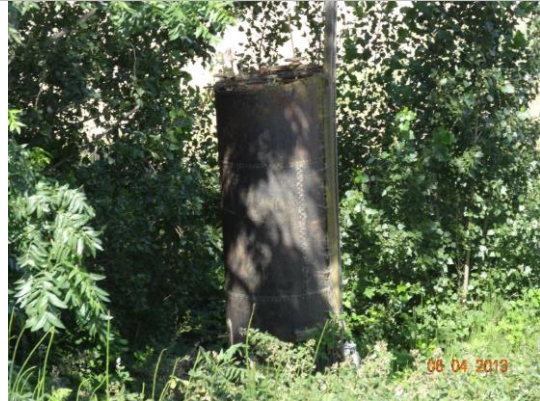
Photo 2 of 3 : UCIP_FA_2015_3697.jpg

Action/Comments					
Inspector Comments: FS_ID:32526 DS_ID:21022 EP_NO: 2742 FS_HLM: 2.83 Repair Type: Non-Urgent Crossing Status: Found UCIP Comments: Dense vegetation limits the inspector's visibility to identify signs of pipe failure (leaks) through the levee slopes. Recommend removing vegetation along pipe alignment to conduct proper inspection of structure and appurtenances. Additional notes: pump was running during inspection, 16-inch pipe debris section located on landward side, view of standpipe and support structure on waterward side does not match structure description--need to determine if crossing has been altered. FIELD_STRUCT_DESC: 16-inch drainpipe through the levee, 3.6 feet below the crown. Cutoff walls around pipe at center of levee. Siphon breaker on apex of pipe at landward shoulder. Pump house on landward shoulder. Pipe discharges into 48-inch pipe with screw gate on landward side. (Permit No. 2742-1959). Repairs made to pipe and a portion replaced, from landward shoulder to discharge end on waterward side, under Permit No. 15380 (1999). Rock revetment placed on waterward slope. Revegetation in progress on waterside. FS Date: 06/04/2013

Standpipe on landward toe.

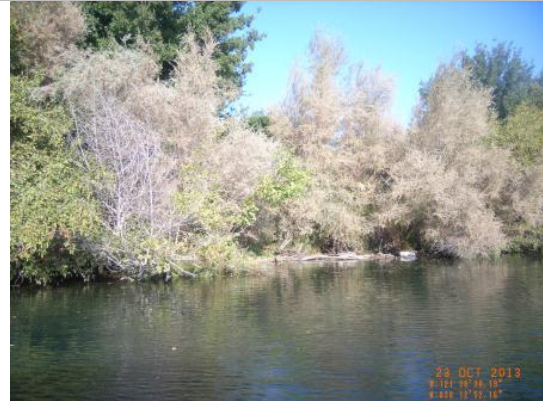
Photo 1 of 1 : USACE2013A_STM_18-9_R_3.jpg

LM Start	2.85	Rating **	M	Issue No.	3
LM End	2.91	Issue Type +	Ma	Location *	WS
Category	Supplemental			GPS Latitude/Longitude	
				Start	End
Item	2015 USACE Erosion Survey, DRAFT			38.214838 °	38.214075 °
				-121.608129 °	-121.608750 °
DWR ID					
Action/Comments					
Inspector Comments: 2009 - Rock is starting to unravel, probably from a tree pop-out, hard toe. 2015: No observed changes. [2015 Site ID: STM_18-9_R]

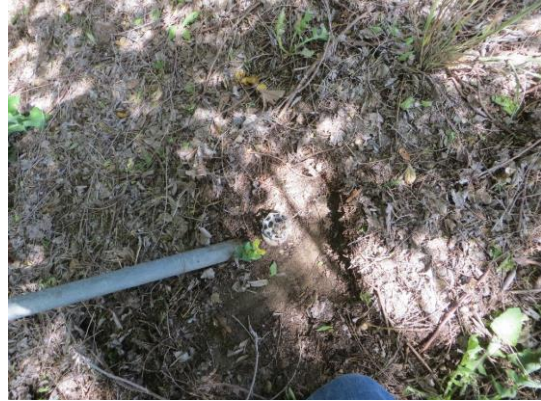
Photo 1 of 2 : UCIP_FA_2015_6221.jpg

Shutoff valve at LS shoulder.

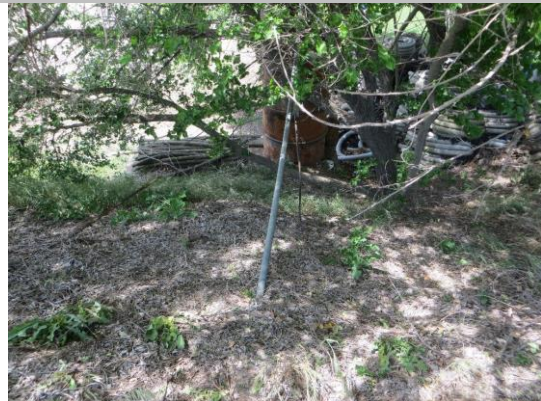
Photo 2 of 2 : UCIP_FA_2015_6222.jpg

Pipe visible at LS shoulder. Pipe connects to top of steel standpipe at LS toe.

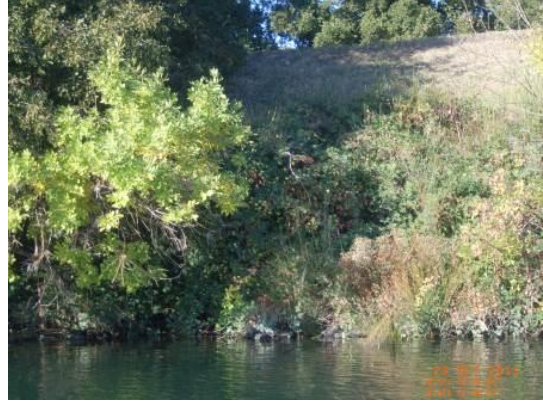
Photo 1 of 1 : USACE2013A_STM_18-8_R_5.jpg

LM Start	3.04	Rating **	M	Issue No.	2
LM End	3.11	Issue Type +	Ma	Location *	WS
Category	Supplemental			GPS Latitude/Longitude	
				Start	End
Item	2015 USACE Erosion Survey, DRAFT			38.212573 °	38.211596 °
				-121.609760 °	-121.609928 °
DWR ID					
Action/Comments					
Inspector Comments: 2000 - Slow erosion of lower and mid-slope with rock bench at the low water line. 2015: No observed changes. [2015 Site ID: STM_18-8_R]

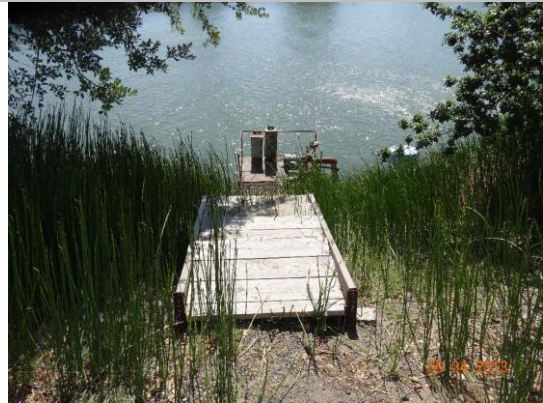
Photo 1 of 3 : UCIP_FA_2015_3699.jpg

LM Start	3.12	Rating **	U	Issue No.	988
LM End	3.12	Issue Type +	En	Location *	WS
Category	Supplemental			GPS Latitude/Longitude	
				Start	End
Item	DWR UCIP Field Study			38.211386 °	38.211386 °
				-121.610189 °	-121.610189 °
DWR ID					
Action/Comments					
Inspector Comments: FS_ID:42925					
DS_ID:21026					
EP_NO: N/A					
FS_HLM: 3.14					
Repair Type: Urgent					
Crossing Status: Found					
UCIP Comments: Damage present to pipe (leak). Additional notes available: 8-inch is leaking on landward side--white sealant and rag used to seal hole, single line crack on the crown of the alignment, pipe through the levee could be bigger than 8-inch unable to confirm. Also found a 3-inch steel pipe approximately 7 feet upstream from 8-inch pipe (authorized or unauthorize?). Need to contact owner to coordinate with CVFPB.					
FIELD_STRUCT_DESC: 8-inch steel pipe and 1.5-inch steel electrical conduit through the levee, both 2.0 feet below the crown. Gate valve on waterward side. Cutoff wall around pipe and conduit at center of levee. Siphon breaker on apex of pipe at landside shoulder. Pump on piling structure on waterward slope installed under Permit No. 9880 (1975). Meter pole at landward toe. Pipe exposed along landward slope. Discharge filter on landward slope installed under Permit No. 9880-B (1975).

Station details--gate valve, air vent, and other appurtenances.

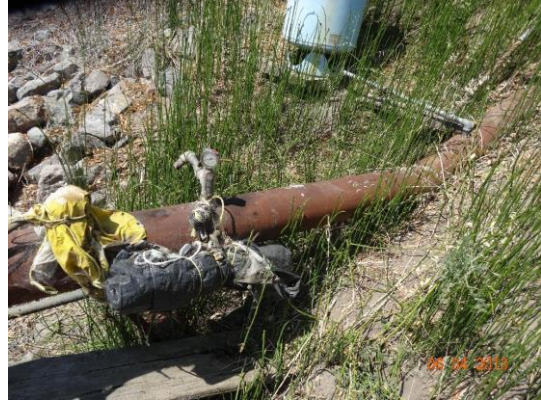
Photo 3 of 3 : UCIP_FA_2015_3701.jpg

LM Start	3.12	Rating **	U	Issue No.	988 (cont)
LM End	3.12	Issue Type +	En	Location *	WS
Category	Supplemental			GPS Latitude/Longitude	
				Start	End
Item	DWR UCIP Field Study			38.211386 °	38.211386 °
				-121.610189 °	-121.610189 °
DWR ID					
Action/Comments					
Inspector Comments: FS_ID:42925 DS_ID:21026 EP_NO: N/A FS_HLM: 3.14 Repair Type: Urgent Crossing Status: Found UCIP Comments: Damage present to pipe (leak). Additional notes available: 8-inch is leaking on landward side--white sealant and rag used to seal hole, single line crack on the crown of the alignment, pipe through the levee could be bigger than 8-inch unable to confirm. Also found a 3-inch steel pipe approximately 7 feet upstream from 8-inch pipe (authorized or unauthorized?). Need to contact owner to coordinate with CVFPB. FIELD_STRUCT_DESC: 8-inch steel pipe and 1.5-inch steel electrical conduit through the levee, both 2.0 feet below the crown. Gate valve on waterward side. Cutoff wall around pipe and conduit at center of levee. Siphon breaker on apex of pipe at landside shoulder. Pump on piling structure on waterward slope installed under Permit No. 9880 (1975). Meter pole at landward toe. Pipe exposed along landward slope. Discharge filter on landward slope installed under Permit No. 9880-B (1975). FS Date: 06/04/2013

View of waterward side--pressure gauge, conduit, and wraps to prevent leaks.

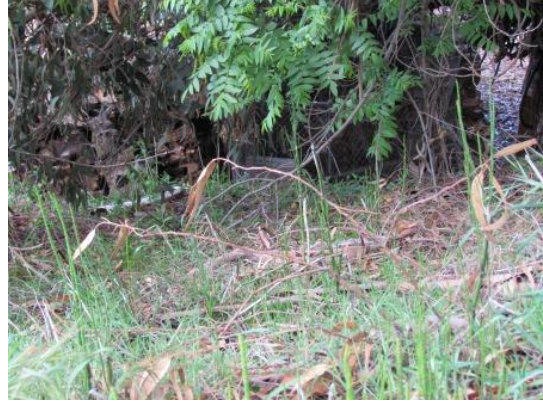
Photo 1 of 1 : FA_2015_RD0501_169_63_20150915_00005.jpg

LM Start	3.24	Rating **	U	Issue No.	63
LM End	3.24	Issue Type +	En	Location *	LS
Category	Earthen Levee			GPS Latitude/Longitude	
				Start	End
Item	Encroachments			38.209811 °	38.209713 °
				-121.610813 °	-121.610882 °
DWR ID	DWR_RD0501_01_f_2012_63				
Action/Comments					
Material Inspector Comments: There is stock pile of equipment and materials on the levee section that needs to be removed off the levee. No new photo taken of this issue 2014.

Equipment and other material on slope and toe of levee section.

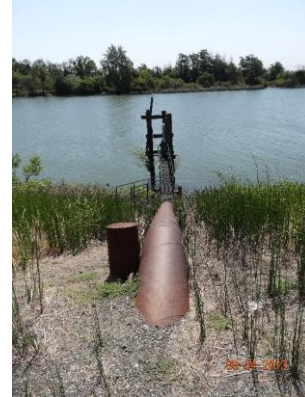
Photo 1 of 3 : UCIP_FA_2015_3702.jpg

Inspector Comments: FS_ID:32529
 DS_ID:21028
 EP_NO: N/A
 FS_HLM: 3.48
 Repair Type: Non-Urgent
 Crossing Status: Found
 UCIP Comments: Pipe was running during inspection. Crack on crown surface could be associated with pipe vibration during operation. Need to determine owner of crossing. Owner will need to clear vegetation along pipe alignment on landward side to prevent levee inspection along crossing.
 FIELD_STRUCT_DESC: 20-inch pipe through the levee, 2.2 feet below the crown. 1.5-inch electrical conduit along side 20 inch pipe. Pump on platform on waterward side. Walkway present on waterward side. Stand pipe located on landward toe. Pipe exposed along both slopes. (USACE-1959). This entry matches the Drainage or Irrigation Structure referenced in O&M manual (HLM 3.70).
 FS Date: 06/04/2013

View of waterward side--siphon breaker, walkway, platform, pump, and control panel.

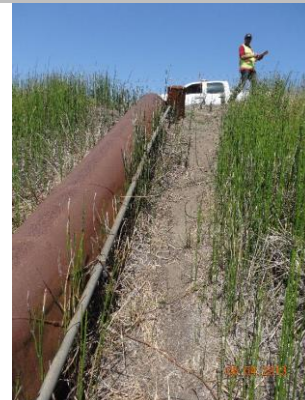
Photo 2 of 3 : UCIP_FA_2015_3703.jpg

20-inch steel pipe along with 1.5-inch electrical conduit on landward side.

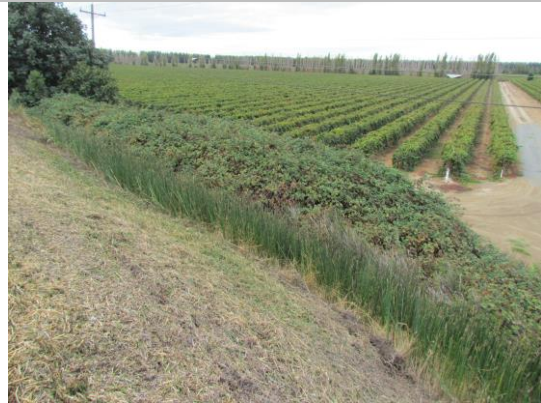
Photo 1 of 1 : FA_2015_RD0501_169_140_20151005_00016.jpg

LM Start	3.48	Rating **	M	Issue No.	140
LM End	3.58	Issue Type +	Ma	Location *	LS
Category	Earthen Levee			GPS Latitude/Longitude	
				Start	End
Item	Vegetation			38.206494 °	38.205020 °
				-121.612244 °	-121.612824 °
DWR ID	DWR_RD0501_01_f_2013_140				
Action/Comments					
Remove the wild growth other than native grasses from the levee slopes. Inspector Comments: RD 501 was working in this area during inspection and plans to remove these berries.

Unsatisfactory wild growth of berries on the landward levee slope and toe.

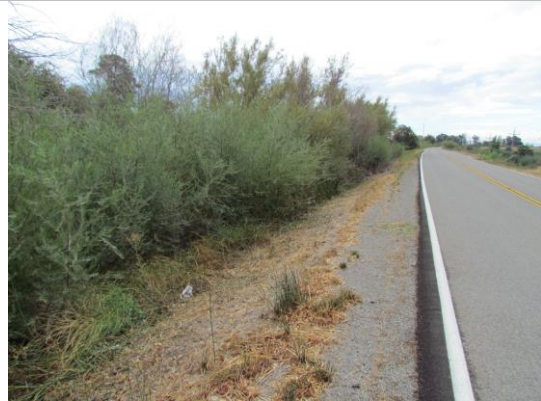
Photo 1 of 1 : FA_2015_RD0501_169_974_20151005_00017.jpg

LM Start	3.75	Rating **	U	Issue No.	974
LM End	4.12	Issue Type +	Ma	Location *	WS
Category	Earthen Levee			GPS Latitude/Longitude	
				Start	End
Item	Vegetation			38.202657 °	38.197778 °
				-121.613553 °	-121.616080 °
DWR ID	DWR_RD0501_01_s _ 2012_974				
Action/Comments					
Remove the wild growth other than native grasses from the levee slopes.					
Inspector Comments: Remove the wild growth from the waterside slope.

Unsatisfactory wild tree growth on the waterside slope.

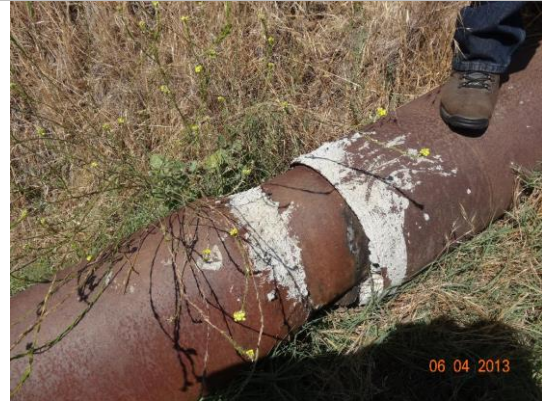
Photo 1 of 3 : UCIP_FA_2015_1709.jpg

UCIP Comments: Pipe section was altered/modified through levee crown. 12-inch pipe sleeved through existing pipe. Dense vegetation limits the inspector's visibility to identify signs of pipe failure (leaks) through the slope. Additional Notes: electrical conduit is disconnected on landside. Recommend removing vegetation along pipe alignment to conduct proper inspection of structure and appurtenances. Also need to contact owner to obtain maintenance records for crossing--need permit authorizing modifications.

12-inch pipe sleeved through existing 14-inch pipe, and annular space grouted--waterward side.

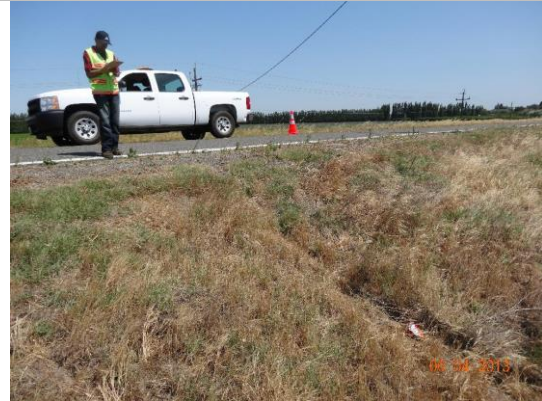
Photo 2 of 3 : UCIP_FA_2015_1710.jpg

UCIP Comments: Pipe section was altered/modified through levee crown. 12-inch pipe sleeved through existing pipe. Dense vegetation limits the inspector's visibility to identify signs of pipe failure (leaks) through the slope. Additional Notes: electrical conduit is disconnected on landside. Recommend removing vegetation along pipe alignment to conduct proper inspection of structure and appurtenances. Also need to contact owner to obtain maintenance records for crossing--need permit authorizing modifications.

View of waterward side.

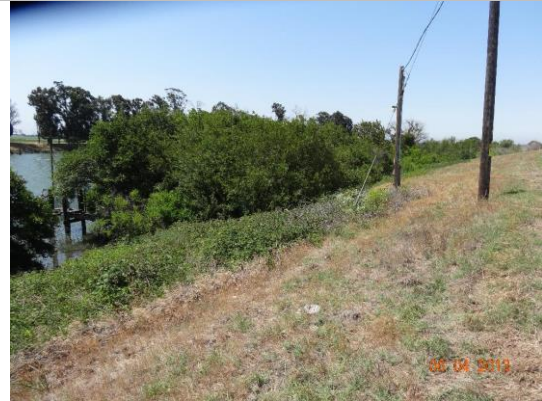
Photo 3 of 3 : UCIP_FA_2015_1711.jpg

Inspector Comments: FS_ID:19644
DS_ID:21016
EP_NO: N/A
FS_HLM: 4.29
Repair Type: Non-Urgent
Crossing Status: Found
UCIP Comments: Pipe section was altered/modified through levee crown. 12-inch pipe sleeved through existing pipe. Dense vegetation limits the inspector's visibility to identify signs of pipe failure (leaks) through the slope. Additional Notes: electrical conduit is disconnected on landside. Recommend removing vegetation along pipe alignment to conduct proper inspection of structure and appurtenances. Also need to contact owner to obtain maintenance records for crossing--need permit authorizing modifications.
FIELD_STRUCT_DESC: 14-inch pipe through the levee, 3.2 feet below the crown. 12-inch pipe sleeved through existing 14-inch pipe and annular space grouted. 1.5-inch electrical conduit runs parallel along 14-inch pipe. Pump on pile structure in channel. Walkway to pump. (USACE-1959). This entry matches the Drainage or Irrigation Structure referenced in O&M manual (HLM 4.30).

Overview of waterward side--pump station, platform, & power pole.

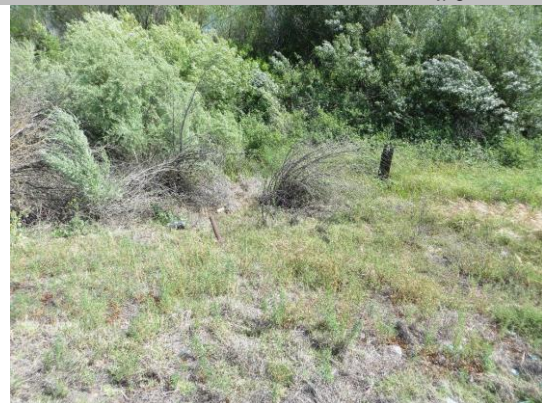
Photo 1 of 2 : UCIP_FA_2015_6223.jpg

Inspector Comments: FS_ID:44716
DS_ID:21017
EP_NO: N/A
FS_HLM: 4.36
Repair Type: Urgent
Crossing Status: Found
UCIP Comments: Pipe abandoned and open on WS slope. Should be removed or abandoned properly.
FIELD_STRUCT_DESC: 2.5-inch steel electrical conduit through the levee 4-feet below the crown. No Location marker on waterward slope.
FS Date: 04/21/2015

2.5-inch conduit visible on WS slope.

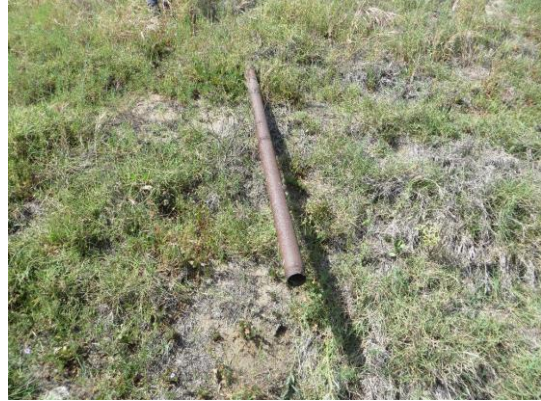
Photo 2 of 2 : UCIP_FA_2015_6224.jpg

LM Start	4.34	Rating **	U	Issue No.	991 (cont)
LM End	4.34	Issue Type +	En	Location *	LS
Category	Supplemental			GPS Latitude/Longitude	
				Start	End
Item	DWR UCIP Field Study			38.195627 °	38.195627 °
				-121.619082 °	-121.619082 °
DWR ID					
Action/Comments					
Inspector Comments: FS_ID:44716 DS_ID:21017 EP_NO: N/A FS_HLM: 4.36 Repair Type: Urgent Crossing Status: Found UCIP Comments: Pipe abandoned and open on WS slope. Should be removed or abandoned properly. FIELD_STRUCT_DESC: 2.5-inch steel electrical conduit through the levee 4-feet below the crown. No Location marker on waterward slope. FS Date: 04/21/2015

2.5-inch conduit visible on WS slope.

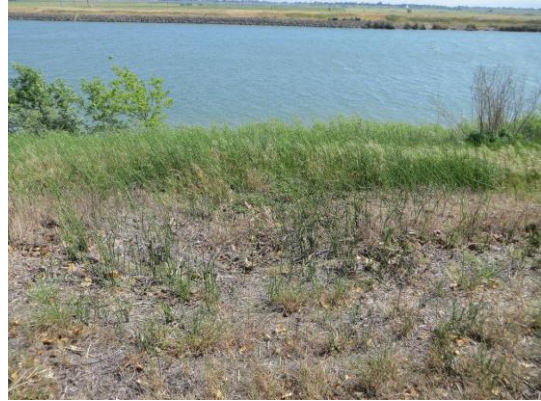
Photo 1 of 3 : UCIP_FA_2015_6225.jpg

Inspector Comments: FS_ID:44720
 DS_ID:21103
 EP_NO: N/A
 FS_HLM: 4.6
 Repair Type: Non-Urgent
 Crossing Status: Indicator Found
 UCIP Comments: Need to verify type of abandonment and if needed abandon it properly.
 FIELD_STRUCT_DESC: *ABANDONED* 12-inch pipe through the levee, 3.0 feet below the crown. (USACE-1959). This entry matches the Drainage or Irrigation Structure referenced in O&M manual (HLM 4.90). A 1.5-inch electrical conduit is visible on the LS slope 3-feet below the crown (good indicator for pipe crossing).
 FS Date: 04/21/2015

Depression on WS shoulder across from pipe may be a good indicator of pipe location.

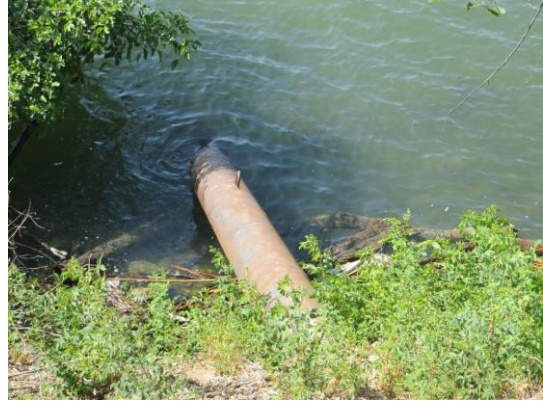
Photo 1 of 3 : UCIP_FA_2015_6228.jpg

LM Start	5.04	Rating **	M	Issue No.	993
LM End	5.04	Issue Type +	En	Location *	LS
Category	Supplemental			GPS Latitude/Longitude	
				Start	End
Item	DWR UCIP Field Study			38.195009 °	38.195009 °
				-121.631548 °	-121.631548 °
DWR ID					
Action/Comments					
Inspector Comments: FS_ID:44726 DS_ID:21018 EP_NO: N/A FS_HLM: 5.07 Repair Type: Non-Urgent Crossing Status: Found UCIP Comments: Crossing appears abandoned as there are no connections at siphon pump on LS shoulder. If it is abandoned it should be done so properly. FIELD_STRUCT_DESC: 14-inch steel irrigation pipe sleeved through a 16-inch steel pipe through the levee, 3-feet below the crown. Annular space grouted. Siphon pump/breaker on landward shoulder. Steel standpipe with slidegate at landward toe. (USACE-1959). This entry matches the Drainage or Irrigation Structure referenced in O&M manual (HLM 5.40). FS Date: 04/23/2015

Pipe visible on WS toe.

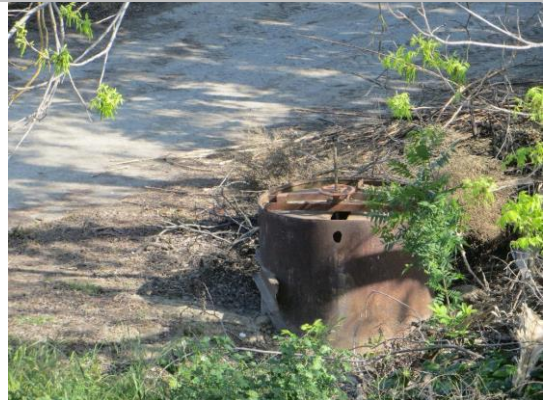
Photo 2 of 3 : UCIP_FA_2015_6229.jpg

Steel standpipe and gatevalve on LS toe.

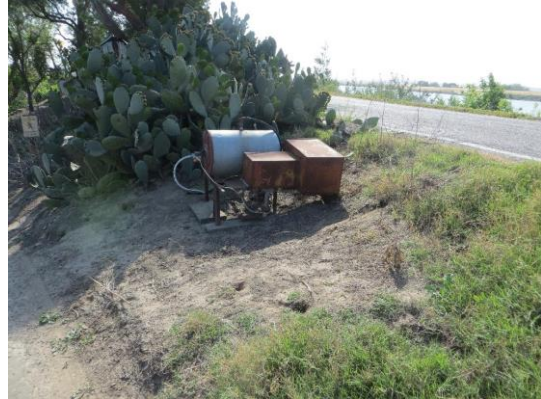
Photo 3 of 3 : UCIP_FA_2015_6230.jpg

LM Start	5.04	Rating **	M	Issue No.	993 (cont)
LM End	5.04	Issue Type +	En	Location *	LS
Category	Supplemental			GPS Latitude/Longitude	
				Start	End
Item	DWR UCIP Field Study			38.195009 °	38.195009 °
				-121.631548 °	-121.631548 °
DWR ID					
Action/Comments					
Inspector Comments: FS_ID:44726 DS_ID:21018 EP_NO: N/A FS_HLM: 5.07 Repair Type: Non-Urgent Crossing Status: Found

Siphon pump on LS shoulder. No connection at this time.

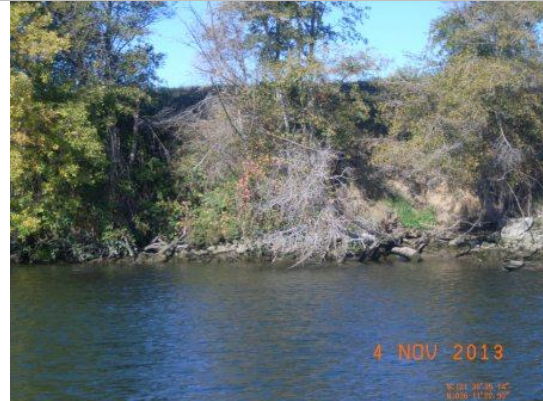
Photo 1 of 1 : USACE2013A_STM_15-7_R_5.jpg

LM Start	5.77	Rating **	M	Issue No.	1
LM End	5.84	Issue Type +	Ma	Location *	WS
Category	Supplemental			GPS Latitude/Longitude	
				Start	End
Item	2015 USACE Erosion Survey, DRAFT			38.190001 °	38.189311 °
				-121.643160 °	-121.643917 °
DWR ID					
Action/Comments					
Inspector Comments: 2008 - Overstepped levee section with multiple small pockets of erosion 10 - 20 ft wide. 2013 - Site has fresh erosion and taller vertical sections. 2015: No observed changes. [2015 Site ID: STM_15-7_R]

USACE 2013 Photo #1

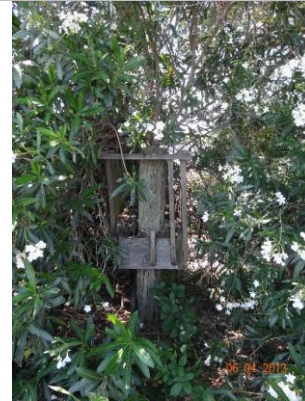
Photo 1 of 3 : UCIP_FA_2015_3705.jpg

LM Start	6.66	Rating **	M	Issue No.	994
LM End	6.66	Issue Type +	En	Location *	WS
Category	Supplemental			GPS Latitude/Longitude	
				Start	End
Item	DWR UCIP Field Study			38.183961 °	38.183961 °
				-121.656860 °	-121.656860 °
DWR ID					
Action/Comments					
Inspector Comments: FS_ID:32530 DS_ID:21020 EP_NO: N/A FS_HLM: 6.7 Repair Type: Non-Urgent Crossing Status: Found UCIP Comments: Dense vegetation limits the inspector's visibility to identify signs of pipe failure (leaks) through the slope. Recommend removing vegetation along pipe alignment to conduct proper inspection of structure and appurtenances. If structure is no longer used--Need to contact owner to determine status. If crossing is no longer used owner will need to coordinate with CVFPB. FIELD_STRUCT_DESC: Abandoned 16-inch pipe through the levee, 6.5 feet below the crown. Siphon breaker and service pole on landward shoulder. Electrical box on landside toe. Pump on pile stucture in channel. FS Date: 06/04/2013

Electrical box visible on landward toe.

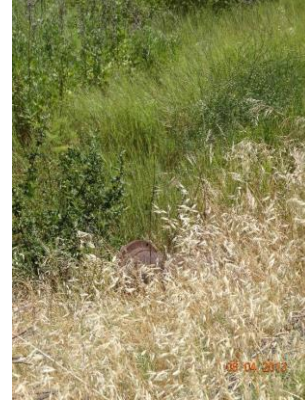
Photo 2 of 3 : UCIP_FA_2015_3706.jpg

Item	DWR UCIP Field Study			38.183961 °	38.183961 °	
				-121.656860 °	-121.656860 °	
DWR ID						
Action/Comments						
Inspector Comments: FS_ID:32530 DS_ID:21020 EP_NO: N/A FS_HLM: 6.7 Repair Type: Non-Urgent Crossing Status: Found UCIP Comments: Dense vegetation limits the inspector's visibility to identify signs of pipe failure (leaks) through the slope. Recommend removing vegetation along pipe alignment to conduct proper inspection of structure and appurtenances. If structure is no longer used--Need to contact owner to determine status. If crossing is no longer used owner will need to coordinate with CVFPB. FIELD_STRUCT_DESC: Abandoned 16-inch pipe through the levee, 6.5 feet below the crown. Siphon breaker and service pole on landward shoulder. Electrical box on landside toe. Pump on pile stucture in channel. FS Date: 06/04/2013

Overview of waterward side--section of pipe visible through dense vegetation.

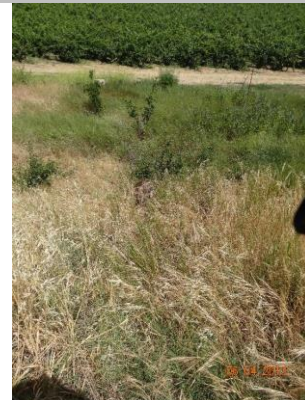
Photo 3 of 3 : UCIP_FA_2015_3856.jpg

Abandoned 16-inch pipe on landward side.

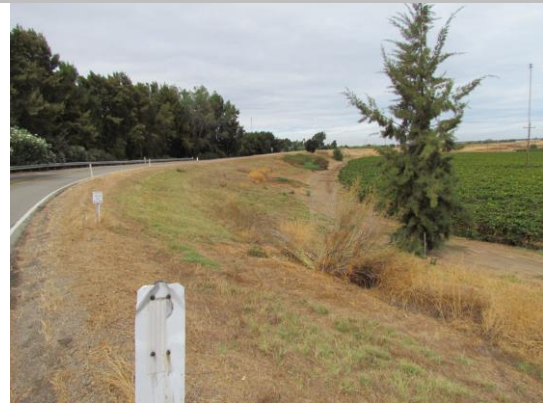
Photo 1 of 1 : FA_2015_RD0501_170_21_20151006_00006.jpg

LM Start	0.00	Rating **	M	Issue No.	21
LM End	0.00	Issue Type +	Ma	Location *	LS
Category	Earthen Levee			GPS Latitude/Longitude	
				Start	End
Item	Vegetation			38.188260 °	38.188260 °
				-121.648701 °	-121.648700 °
DWR ID	DWR_RD0501_02_s _ 2012_21				
Action/Comments					
Remove the wild growth other than native grasses from the levee slopes.					
Inspector Comments: Mow the tall weeds at toe of levee slope.

Looking downstream from levee mile 0.00 at the landside slope. Few scattered tall weeds at the toe.

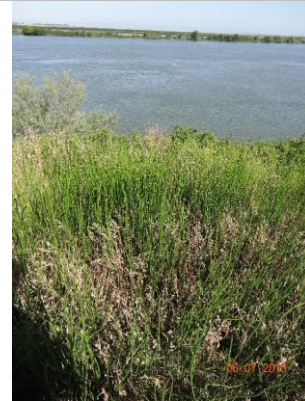
Photo 1 of 3 : UCIP_FA_2015_3857.jpg

LM Start	0.56	Rating **	M	Issue No.	29
LM End	0.56	Issue Type +	En	Location *	WS
Category	Supplemental			GPS Latitude/Longitude	
				Start	End
Item	DWR UCIP Field Study			38.191452 °	38.191452
				-121.656188 °	-121.656188
DWR ID					
Action/Comments					
Inspector Comments: FS_ID:32531 DS_ID:21035 EP_NO: N/A FS_HLM: 0.56 Repair Type: Non-Urgent Crossing Status: Found UCIP Comments: Dense vegetation limits the inspector's visibility to identify signs of pipe failure (leaks) through the slope. Recommend removing vegetation along pipe alignment to conduct proper inspection of structure and appurtenances. Need to determine owner and status of crossing. FIELD_STRUCT_DESC: 10-inch pipe sleeved through a 12-inch pipe through the levee, 5.0 feet below the crown. Pump on waterward side. (USACE-1959). This entry matches the Drainage or Irrigation Structure referenced in O&M manual (HLM 0.60). FS Date: 06/07/2013

Overview of waterward side. Inaccessible due to dense vegetation.

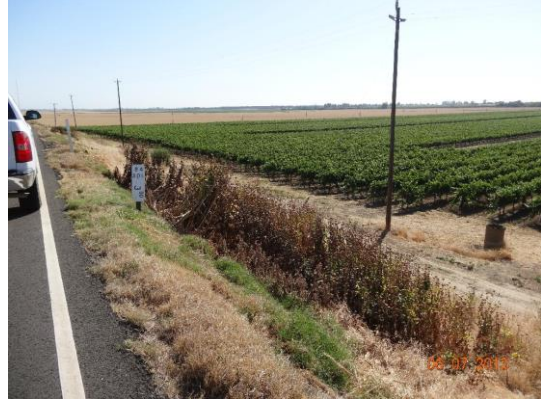
Photo 2 of 3 : UCIP_FA_2015_3858.jpg

LM Start	0.56	Rating **	M	Issue No.	29 (cont)
LM End	0.56	Issue Type +	En	Location *	WS
Category	Supplemental			GPS Latitude/Longitude	
				Start	End
Item	DWR UCIP Field Study			38.191452 °	38.191452 °
				-121.656188 °	-121.656188 °
DWR ID					
Action/Comments					
Inspector Comments: FS_ID:32531 DS_ID:21035 EP_NO: N/A FS_HLM: 0.56 Repair Type: Non-Urgent Crossing Status: Found UCIP Comments: Dense vegetation limits the inspector's visibility to identify signs of pipe failure (leaks) through the slope. Recommend removing vegetation along pipe alignment to conduct proper inspection of structure and appurtenances. Need to determine owner and status of crossing. FIELD_STRUCT_DESC: 10-inch pipe sleeved through a 12-inch pipe through the levee, 5.0 feet below the crown. Pump on waterward side. (USACE-1959). This entry matches the Drainage or Irrigation Structure referenced in O&M manual (HLM 0.60). FS Date: 06/07/2013

Overview of landward side.

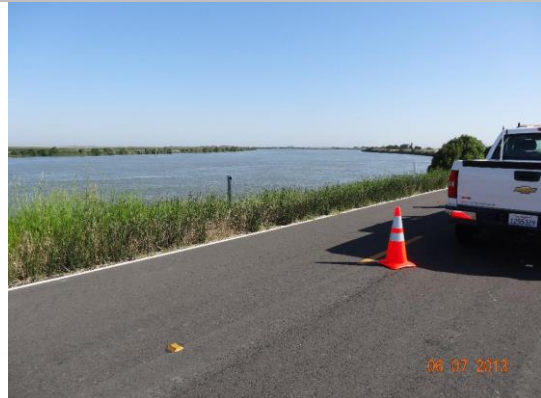
Photo 3 of 3 : UCIP_FA_2015_3859.jpg

View of crown.

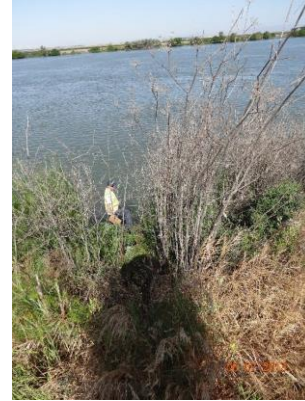
Photo 1 of 3 : UCIP_FA_2015_3860.jpg

LM Start	0.86	Rating **	U	Issue No.	30
LM End	0.86	Issue Type +	En	Location *	WS
Category	Supplemental			GPS Latitude/Longitude	
				Start	End
Item	DWR UCIP Field Study			38.195588 °	38.195588
				-121.655189 °	-121.655189
DWR ID					
Action/Comments					
Inspector Comments: FS_ID:32532					
DS_ID:21092					
EP_NO: 3703					
FS_HLM: 0.858					
Repair Type: Urgent					
Crossing Status: Found

View of waterward side. Inspector is standing near exposed section of pipe at levee toe.

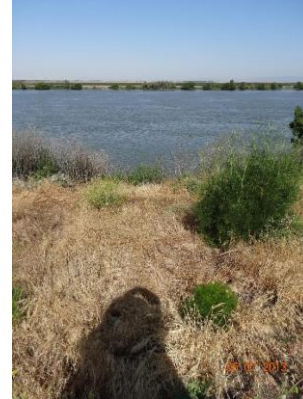
Photo 3 of 3 : UCIP_FA_2015_3890.jpg

LM Start	0.86	Rating **	U	Issue No.	30 (cont)
LM End	0.86	Issue Type +	En	Location *	WS
Category	Supplemental			GPS Latitude/Longitude	
				Start	End
Item	DWR UCIP Field Study			38.195588 °	38.195588
				-121.655189 °	-121.655189
DWR ID					
Action/Comments					
Inspector Comments: FS_ID:32532					
DS_ID:21092					
EP_NO: 3703					
FS_HLM: 0.858					
Repair Type: Urgent					
Crossing Status: Found

Overview of waterward side--20 foot berm present.

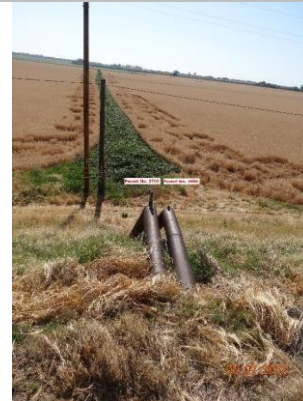
Photo 1 of 3 : UCIP_FA_2015_3891.jpg

LM Start	0.86	Rating **	U	Issue No.	31
LM End	0.86	Issue Type +	En	Location *	WS
Category	Supplemental			GPS Latitude/Longitude	
				Start	End
Item	DWR UCIP Field Study			38.195600 °	38.195600 °
				-121.655191 °	-121.655191 °
DWR ID					
Action/Comments					
Inspector Comments: FS_ID:32533 DS_ID:21036 EP_NO: 1902 FS_HLM: 0.859 Repair Type: Urgent Crossing Status: Found UCIP Comments: Reason for an Urgent Priority is due to adjacent crossing--adjacent crossing has holes present and is was installed in the 1960s. Our records show this pipe was installed before 1955. Dense vegetation limits the inspector's visibility to identify signs of pipe failure (leaks) through the slope. Recommend removing vegetation along pipe alignment to conduct proper inspection of structure and appurtenances. If crossing is no longer in use--Owner will need to coordinate with DWR Inspector and CVFPB. Need to determine condition of pipe--request maintenance records from owner once found--this crossing could be capped and grouted--NEED RECORDS. FIELD_STRUCT_DESC: 8-inch steel pipe through the levee, 1.7 feet below the crown. Siphon breaker on apex of pipe at landward shoulder. Pipe discharges into concrete sump near landward toe. Pipe is exposed along landward slope. (USACE-1959). This entry matches the Drainage or Irrigation Structure referenced in O&M manual (HLM 0.90). Section of pipe, between both shoulders, was removed and replaced with a 10-inch steel pipe under Permit No. 1902 (1959). FS Date: 06/07/2013

8-inch pipes approximately 1 foot apart.

Inspector Comments: FS_ID:32533
 DS_ID:21036
 EP_NO: 1902
 FS_HLM: 0.859
 Repair Type: Urgent
 Crossing Status: Found
 UCIP Comments: Reason for an Urgent Priority is due to adjacent crossing--adjacent crossing has holes present and is was installed in the 1960s. Our records show this pipe was installed before 1955. Dense vegetation limits the inspector's visibility to identify signs of pipe failure (leaks) through the slope. Recommend removing vegetation along pipe alignment to conduct proper inspection of structure and appurtenances. If crossing is no longer in use--Owner will need to coordinate with DWR Inspector and CVFPB. Need to determine condition of pipe--request maintenance records from owner once found--this crossing could be capped and grouted--NEED RECORDS.
 FIELD_STRUCT_DESC: 8-inch steel pipe through the levee, 1.7 feet below the crown. Siphon breaker on apex of pipe at landward shoulder. Pipe discharges into concrete sump near landward toe. Pipe is exposed along landward slope. (USACE-1959). This entry matches the Drainage or Irrigation Structure referenced in O&M manual (HLM 0.90). Section of pipe, between both shoulders, was removed and replaced with a 10-inch steel pipe under Permit No. 1902 (1959).

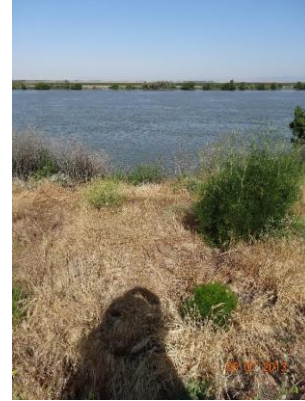
Photo 3 of 3 : UCIP_FA_2015_3893.jpg

LM Start	0.86	Rating **	U	Issue No.	31 (cont)
LM End	0.86	Issue Type +	En	Location *	WS
Category	Supplemental			GPS Latitude/Longitude	
				Start	End
Item	DWR UCIP Field Study			38.195600 °	38.195600 °
				-121.655191 °	-121.655191 °
DWR ID					
Action/Comments					
Inspector Comments: FS_ID:32533 DS_ID:21036 EP_NO: 1902 FS_HLM: 0.859 Repair Type: Urgent Crossing Status: Found UCIP Comments: Reason for an Urgent Priority is due to adjacent crossing--adjacent crossing has holes present and is was installed in the 1960s. Our records show this pipe was installed before 1955. Dense vegetation limits the inspector's visibility to identify signs of pipe failure (leaks) through the slope. Recommend removing vegetation along pipe alignment to conduct proper inspection of structure and appurtenances. If crossing is no longer in use--Owner will need to coordinate with DWR Inspector and CVFPB. Need to determine condition of pipe--request maintenance records from owner once found--this crossing could be capped and grouted--NEED RECORDS. FIELD_STRUCT_DESC: 8-inch steel pipe through the levee, 1.7 feet below the crown. Siphon breaker on apex of pipe at landward shoulder. Pipe discharges into concrete sump near landward toe. Pipe is exposed along landward slope. (USACE-1959). This entry matches the Drainage or Irrigation Structure referenced in O&M manual (HLM 0.90). Section of pipe, between both shoulders, was removed and replaced with a 10-inch steel pipe under Permit No. 1902 (1959). FS Date: 06/07/2013

Overview of waterward side--20 foot berm present.

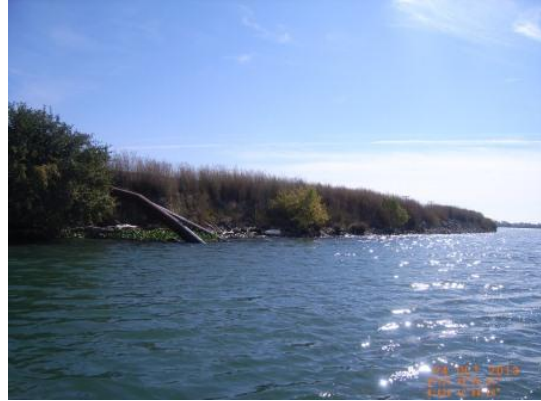
Photo 1 of 1 : USACE2013A_CHS_15-9_L_1.jpg

LM Start	1.10	Rating **	M	Issue No.	1
LM End	1.17	Issue Type +	Ma	Location *	WS
Category	Supplemental			GPS Latitude/Longitude	
				Start	End
Item	2015 USACE Erosion Survey, DRAFT			38.199128 °	38.200146 °
				-121.655881 °	-121.655638 °
DWR ID					
Action/Comments					
Inspector Comments: 2005 - Large vertical sections due to wave wash. New stone dumped on the bank with exposed geotextile. Cohesive toe has thin weak stratigraphic unit that is washing out. 2006 - Partially repaired, but 100 ft in the middle of the reach has exposed filter fabric and stone riprap is gone. 2010 - Site extended downstream to include new erosion pocket. 2015: No observed changes. [2015 Site ID: CHS_15-9_L]

USACE 2013 Photo #1

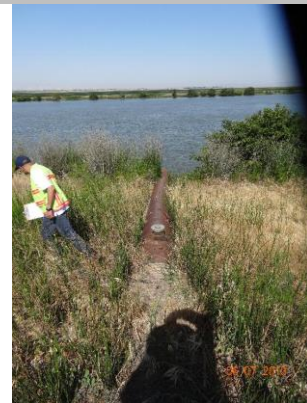
Photo 1 of 3 : UCIP_FA_2015_3894.jpg

LM Start	1.15	Rating **	M	Issue No.	32
LM End	1.15	Issue Type +	En	Location *	WS
Category	Supplemental			GPS Latitude/Longitude	
				Start	End
Item	DWR UCIP Field Study			38.199816 °	38.199816 °
				-121.655395 °	-121.655395 °
DWR ID					
Action/Comments					
Inspector Comments: FS_ID:44865 DS_ID:21038 EP_NO: 2817 FS_HLM: 1.153 Repair Type: Non-Urgent Crossing Status: Found UCIP Comments: Dense vegetation limits the inspector's visibility to identify signs of pipe failure (leaks) through the slope. Recommend removing vegetation along pipe alignment to conduct proper inspection of structure and appurtenances. Scour hole located on waterward side. FIELD_STRUCT_DESC: 20-inch steel drainpipe sleeved through a 24-inch steel pipe through the levee, 9.0 feet below the crown. Flap gate on waterward end. Two cutoff collars around the pipe at both shoulders. Pipe exposed along both slopes. Rock revetment on waterward slope. Berm on waterward side is over 20 feet. (Permit No. 2817-1959) FS Date: 06/07/2013

View of waterward side--pipe section exposed and siphon breaker. Over 20 feet berm on waterward side.

Inspector Comments: FS_ID:44865
 DS_ID:21038
 EP_NO: 2817
 FS_HLM: 1.153
 Repair Type: Non-Urgent
 Crossing Status: Found
 UCIP Comments: Dense vegetation limits the inspector's visibility to identify signs of pipe failure (leaks) through the slope. Recommend removing vegetation along pipe alignment to conduct proper inspection of structure and appurtenances. Scour hole located on waterward side.
 FIELD_STRUCT_DESC: 20-inch steel drainpipe sleeved through a 24-inch steel pipe through the levee, 9.0 feet below the crown. Flap gate on waterward end. Two cutoff collars around the pipe at both shoulders. Pipe exposed along both slopes. Rock revetment on waterward slope. Berm on waterward side is over 20 feet. (Permit No. 2817-1959)
 FS Date: 06/07/2013

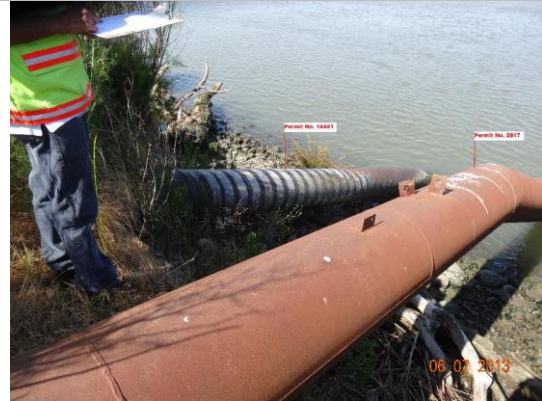
Photo 2 of 3 : UCIP_FA_2015_3895.jpg

Waterward side--2-24 inch pipe inlets.

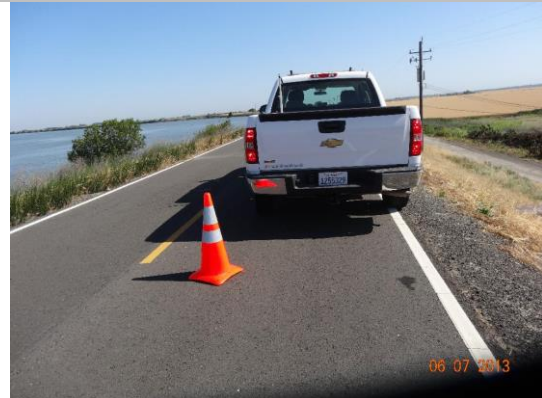
Photo 3 of 3 : UCIP_FA_2015_3896.jpg

View of levee crown at crossings.

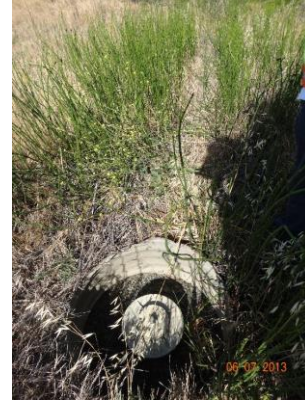
Photo 1 of 3 : UCIP_FA_2015_3897.jpg

LM Start	1.16	Rating **	M	Issue No.	33
LM End	1.16	Issue Type +	En	Location *	WS
Category	Supplemental			GPS Latitude/Longitude	
				Start	End
Item	DWR UCIP Field Study			38.199837 °	38.199837 °
				-121.655391 °	-121.655391 °
DWR ID					
Action/Comments					
Inspector Comments: FS_ID:44866					
DS_ID:21094					
EP_NO: 14491					
FS_HLM: 1.155					
Repair Type: Non-Urgent					
Crossing Status: Found

Siphon breaker located at the waterward shoulder.

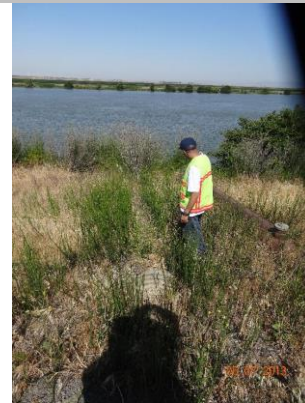
Photo 2 of 3 : UCIP_FA_2015_3898.jpg

Two pipes on waterside.

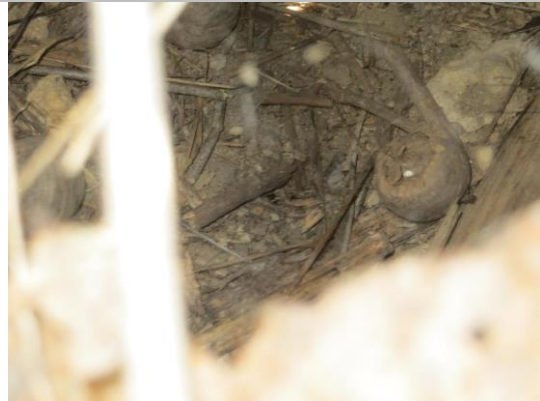
Photo 1 of 3 : UCIP_FA_2015_6260.jpg

LM Start	1.25	Rating **	M	Issue No.	34
LM End	1.25	Issue Type +	En	Location *	WS
Category	Supplemental			GPS Latitude/Longitude	
				Start	End
Item	DWR UCIP Field Study			38.201143 °	38.201143 °
				-121.655169 °	-121.655169 °
DWR ID					
Action/Comments					
Inspector Comments: FS_ID:44753 DS_ID:21085 EP_NO: N/A FS_HLM: 1.25 Repair Type: Non-Urgent Crossing Status: Found UCIP Comments: Hole rusted through pipe on WS end. Pipe abandoned and should be done so properly. FIELD_STRUCT_DESC: Abandoned 20-inch steel pipe through the levee, 15.5 feet below the crown. Pipe exposed along waterward slope, Steel plate welded over end (USACE-1959). This entry matches the Drainage or Irrigation Structure referenced in O&M manual (HLM 1.40). FS Date: 04/23/2015

Inside hole in pipe at WS toe.

Inspector Comments: FS_ID:44753
 DS_ID:21085
 EP_NO: N/A
 FS_HLM: 1.25
 Repair Type: Non-Urgent
 Crossing Status: Found
 UCIP Comments: Hole rusted through pipe on WS end. Pipe abandoned and should be done so properly.
 FIELD_STRUCT_DESC: Abandoned 20-inch steel pipe through the levee, 15.5 feet below the crown. Pipe exposed along waterward slope, Steel plate welded over end (USACE-1959). This entry matches the Drainage or Irrigation Structure referenced in O&M manual (HLM 1.40).
 FS Date: 04/23/2015

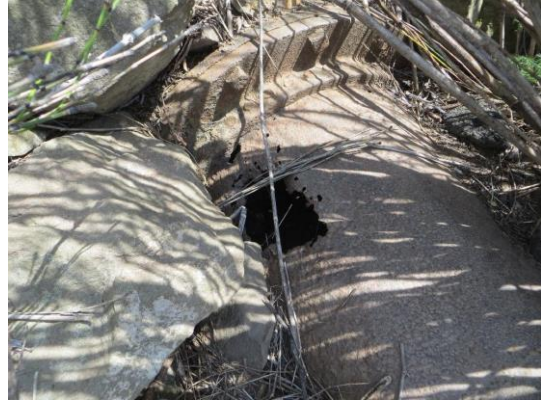
Photo 2 of 3 : UCIP_FA_2015_6261.jpg

Hole in pipe at WS toe.

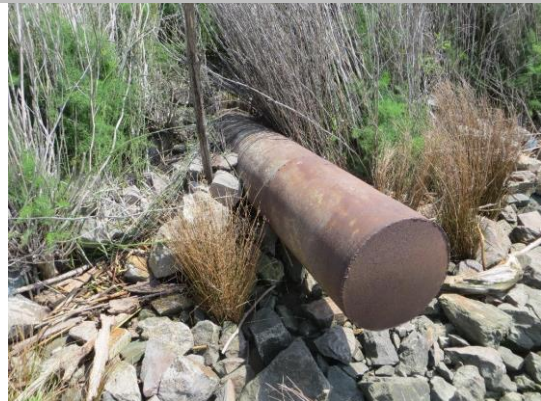
Photo 3 of 3 : UCIP_FA_2015_6262.jpg

20-inch pipe with welded steel plate over end on WS toe.

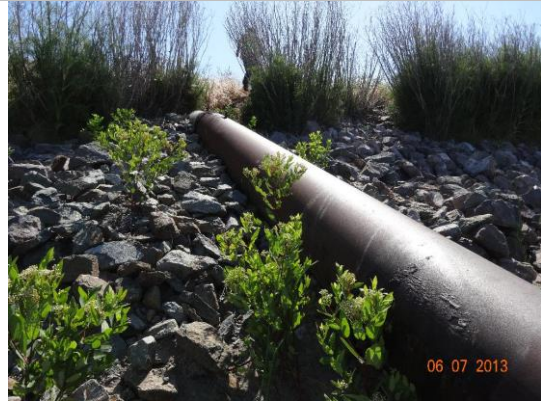
Photo 1 of 3 : UCIP_FA_2015_3900.jpg

LM Start	1.70	Rating **	M	Issue No.	35
LM End	1.70	Issue Type +	En	Location *	WS
Category	Supplemental			GPS Latitude/Longitude	
				Start	End
Item	DWR UCIP Field Study			38.207507 °	38.207507 °
				-121.656219 °	-121.656219 °
DWR ID					
Action/Comments					
Inspector Comments: FS_ID:44867					
DS_ID:21093					
EP_NO: 13520					
FS_HLM: 1.7					
Repair Type: Non-Urgent					
Crossing Status: Found

View of waterward side--pipe extends from berm to river.
